# DC GARDENING SERVICES

## **BISHOPSTONE GROUP PARISH COUNCIL** **REPORT ON JETTING WORKS**

These works have been carried out in conjunction with Mayglothling Waste Ltd.

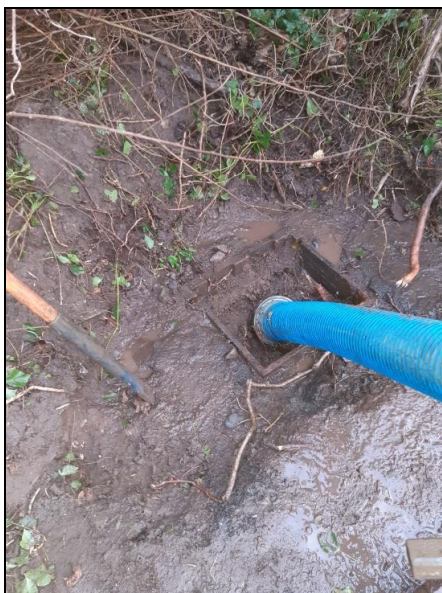
Continuing on down the road on the LHS, another lost drain sitting back in the hedge has been uncovered, this needed major excavation works to uncover it. The pit has been cleared out and the pipework jetted and all is now running. Please see photograph below as found:

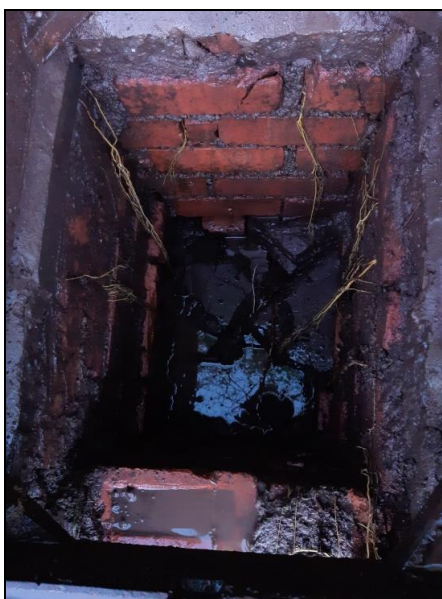
Starting at Byford Church (U90011), clearing of inspection pit just before the Church. This had been reported that during heavy rain, the drain was not taking the water. Having cleared out the chamber with the gully sucker, it appears that this is an old brick chamber with a dirt floor with no pipes apparent either leading in or out of the chamber. The conclusion for this is that this is a soakaway. However, with heavy rain the water will continue to run onto the road once the pit is full and this needs further investigation/action by Balfour Beatty. Please see photograph below:

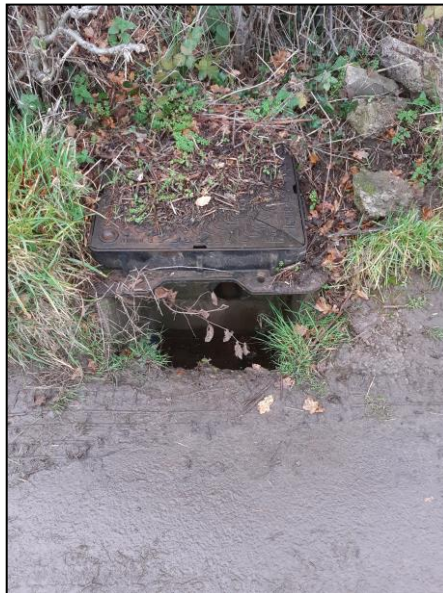
C1097 – leading from Home Farm towards Bishopstone just past Hillside Barn, clearing of pit on LHS of the road which is severely damaged – this will need attention from Balfour Beatty. Please see photograph below:

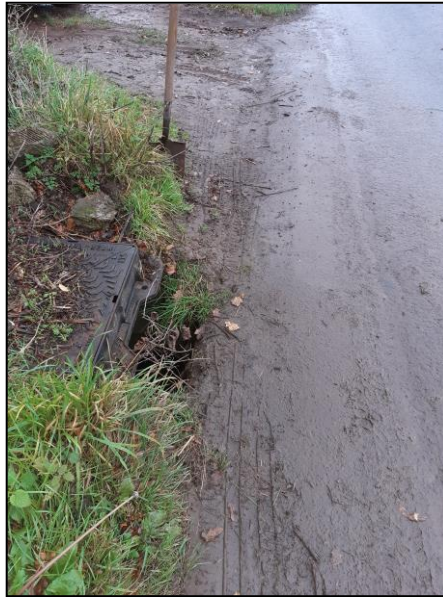
C1098 leading from the junction of C1097 down towards A438 – jetting of pipework and clearance of pits. There is a pit approximately half way down by a farm gate, the edge has collapsed and is very dangerous for car tyres – this needs urgent attention from Balfour Beatty. Please see photograph below:

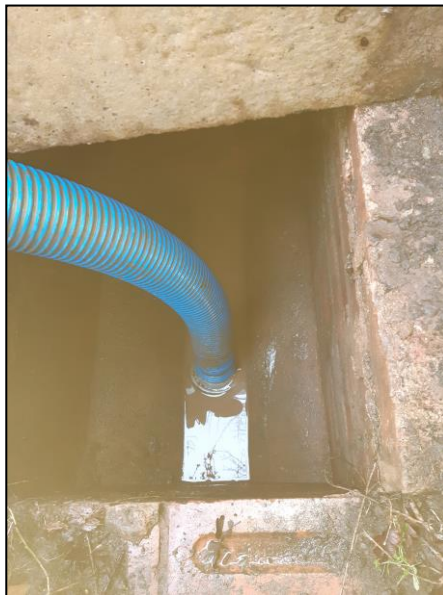
U90010 heading for Byford Common – the resident of White House has raised concerns with regards to flooding of his property. With representatives of the Parish Council (John Macklin and Sue Hubbard) and the resident in question, it was decided to investigate a brick pit with a concrete lid on the RHS of the road in the ditch which leads towards his house. Having taken the lid off, there was a small amount of soil and debris found which was then subsequently sucked out. This uncovered in the bottom of the drain, 2 small clay old fashioned land drain pipe following the direction of the road. The base of the drain has 2 sloping sides. Please see photograph below:

Having jetted this pipe, we could only jet approximately 30-40 metres back up the road and have come to a halt. Also, the pipe has been jetted the other way, towards White House and the length of the pipe was again jetted for approximately 30-40 metres. This has again come to a halt. There are no inspection chambers to lift or any manhole covers along this section.

The homeowner did state that his soakaway from his septic tank does run under his driveway towards the road but does not know where it goes after that. Where he has roughly stated it comes out, is also roughly the length of where the jetter has managed to jet to. The owner of White House has attempted to dig by hand a ditch from his driveway back to the brick pit. If this was dug out to an acceptable depth a new perforated drainage pipe could be put in here and graveled over. It would then need a new pipe to run from the brick pit towards his drive and then underneath the road to connect with the ditch on the opposite side leading around Byford Common.

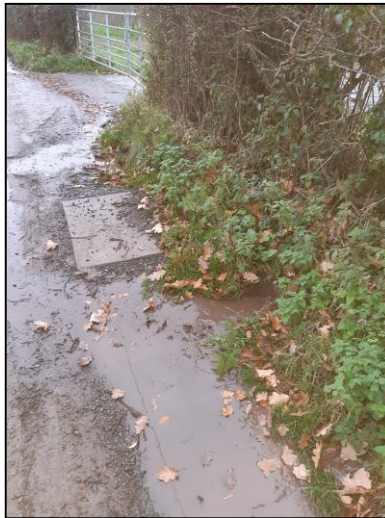
B4230 leading to Mansel Gamage – jetting of culverts on the LHS and RHS of the road all the way up to the first house on the RHS at the top of the hill. Approximately a quarter-way up on the LHS there are 2 double single gates and just past these there is a Telecom box in the floor. Behind this box the water was running down the road when we arrived. Please see photograph below:

Just above the Telecom box by a verge marker there is a drain pit. This has been sucked out and the pipework has been jetted back towards the Telecom box and silver gates. This has made it worse and it is looking like a BT cable has either been put through the drainage pipe or the farm entrance, which has been modified, has damaged the pipework. This would benefit from a CCTV camera survey to hopefully ascertain the problem.
